NATIONAL DAM INSPECTION PROGRAM. TILLSON LAKE DAM (NY 00083), L--ETC(U)

REPORT DOCUMENTATION PAGE		READ INSTRUCTIONS BEFORE COMPLETING FORM
1. REPORT NUMBER	2. GOVT ACCESSION NO.	3. RECIPIENT'S CATALOG NUMBER
AD A105851		
4. TITLE (and Subtitle) Phase I Inspection Report Tillson Lake Dam Lower Hudson River Basin, Ulster County, N.Y. Inventory No. 83		5. TYPE OF REPORT & PERIOD COVERED Phase I Inspection Report National Dam Safety Program

National Dam Inspection Program,
Tillson Lake Dam (NY 00083), Lower
Hudson River Basin, Town of Gardiner,
Ulster County, New York. Phase I
Inspection Report.

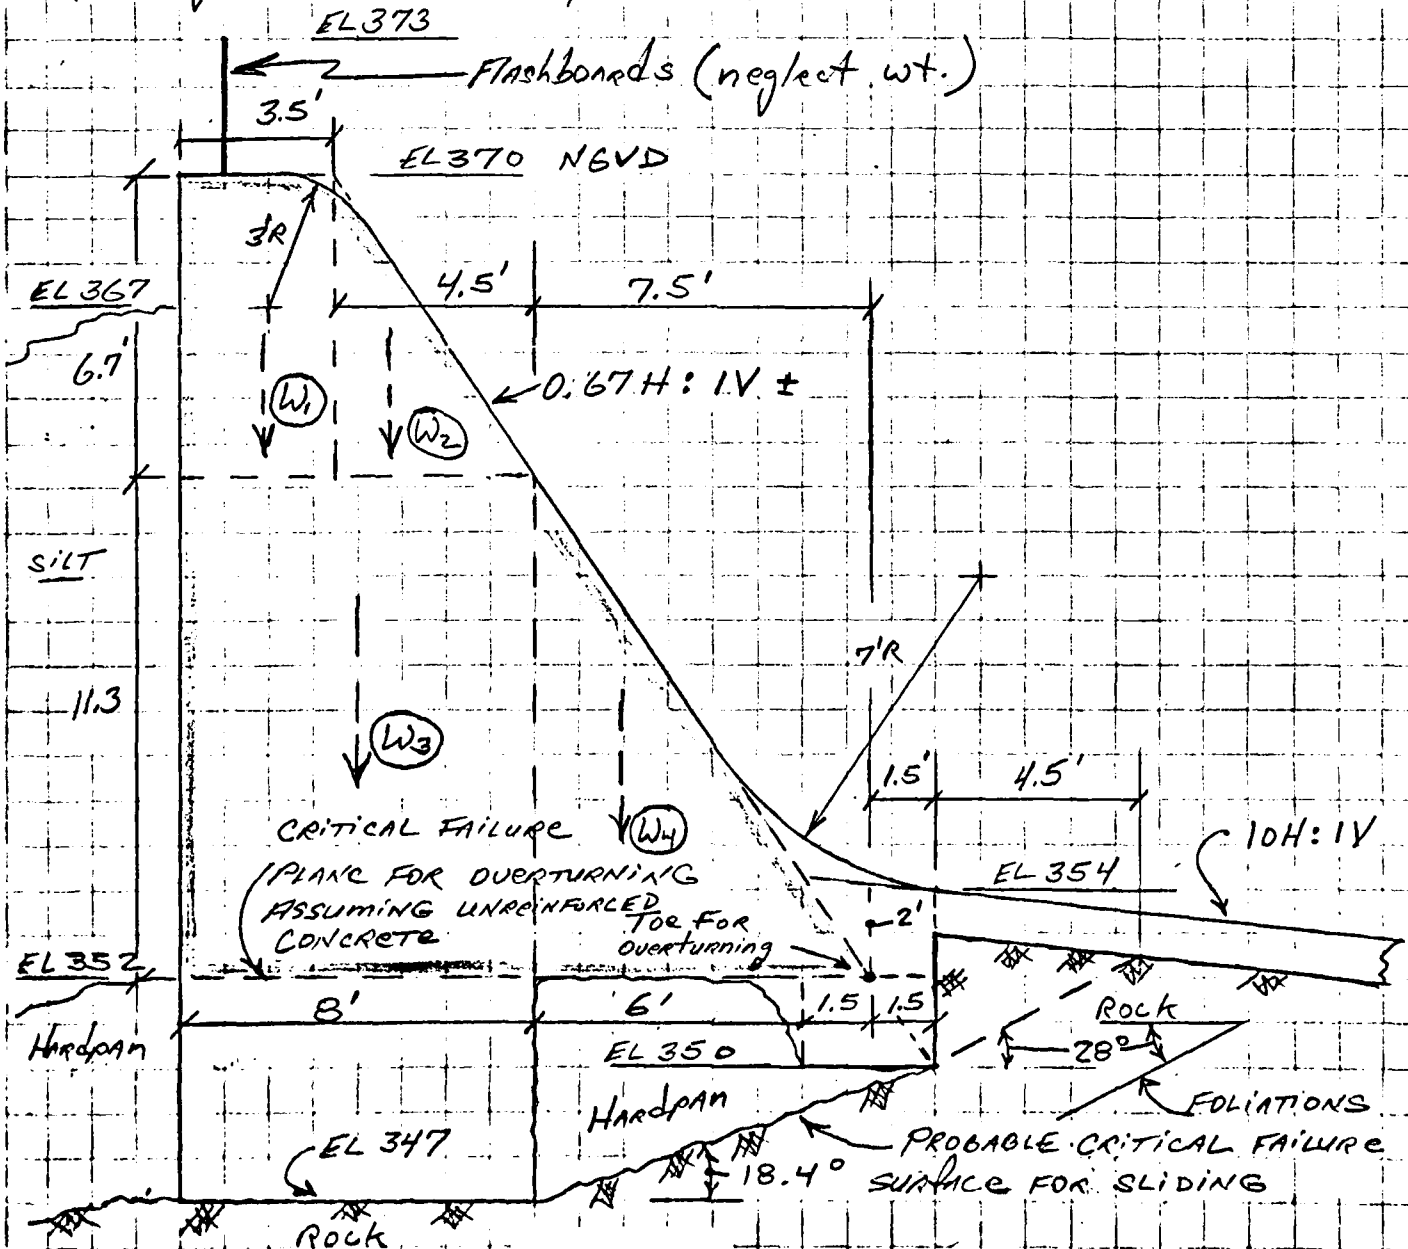
STABILITY ANALYSIS OF SPILLWAY

CROSS SECTION FOR ANALYSIS (10' from right training wall, less than max. height and somewhat free from effects of lateral support of training wall, see Photos A-6A, 6B & 7B & dwg. Appendix G#1, NGVD base 9.0' higher than old dwg. base)

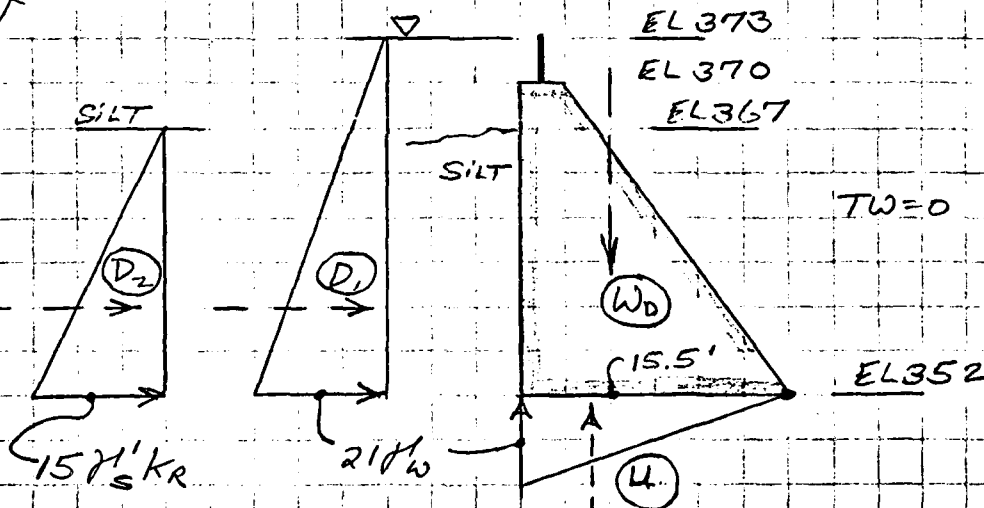
CASE 1 - Normal pool at flashboard crest, full HW uplift, silt 3' below spillway by observation, negligible TW by observation

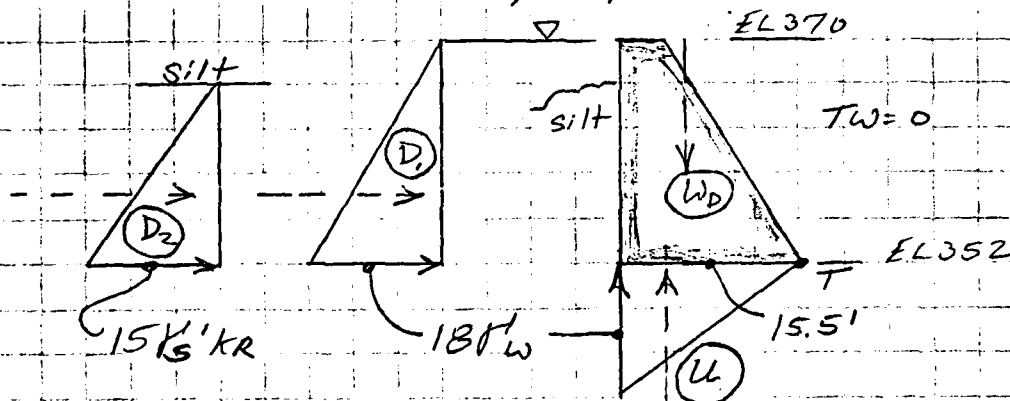
CASE 1A - Same as Case 1, except no flashboards

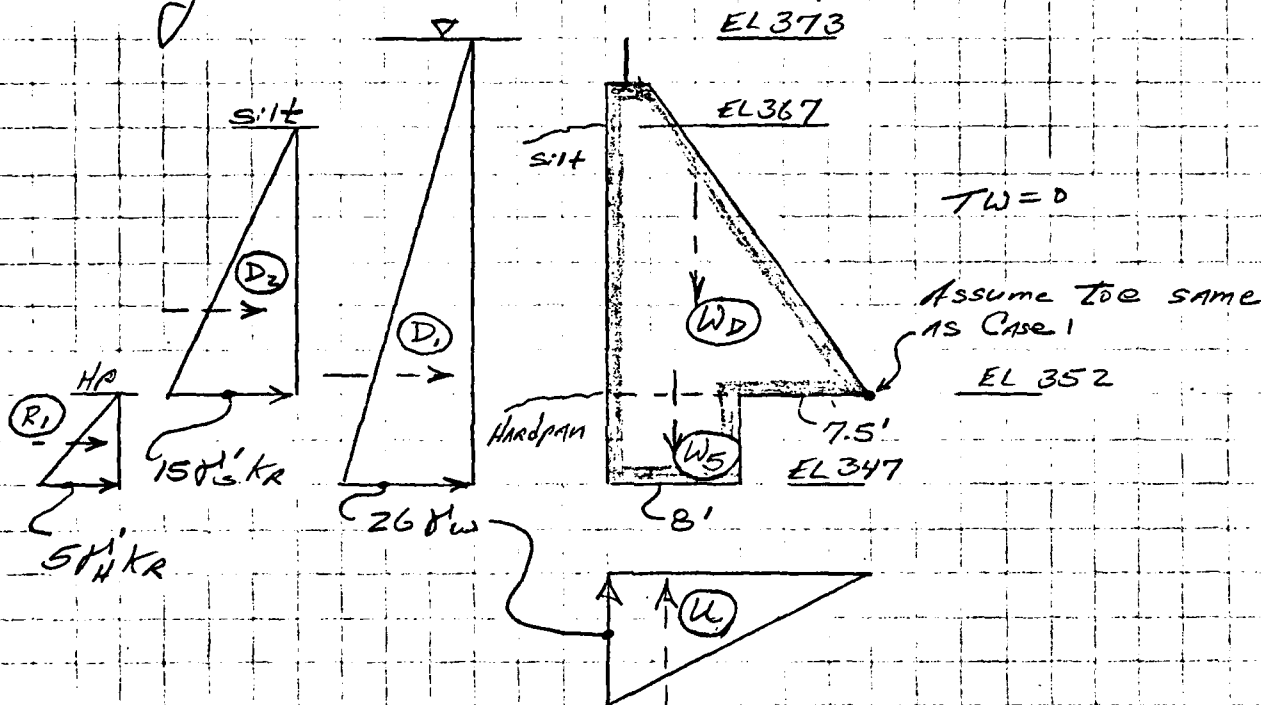
CASE 1B → - Same AS CASE 1, except assume that
u/s shear key can help resist overturning due to:
- unusually large cross section of key
- possible reinforcement in key to take tension
Overturning

$$d = \frac{+114.69}{19.13} = 6.00 \times \frac{6}{15.5} = \underline{0.396} > 1/3 b$$

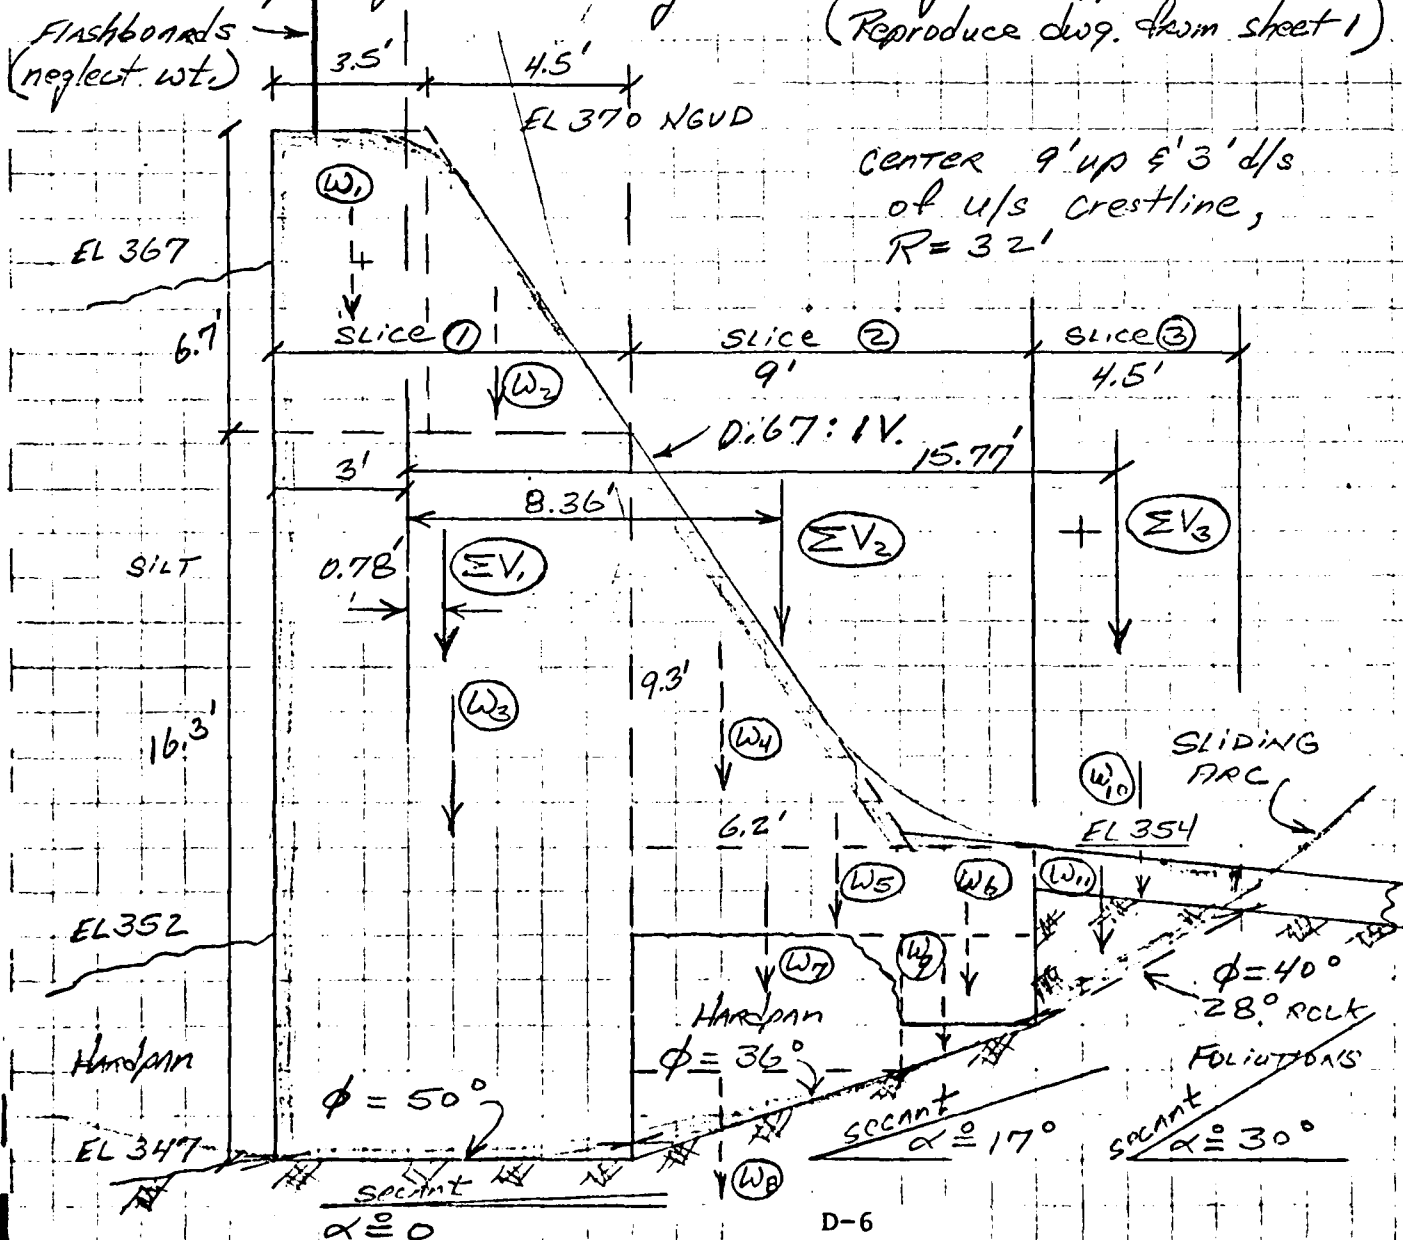
CASE 1 - SLIDING Rock foliations strike $N 30^{\circ} E$ - almost parallel w/ spillway crest - but dip $28^{\circ} N$, i.e. u/s, see dwg. Appendix G-1 for direction. Since dip angle is large and is against direction of sliding, critical failure surface is a circular arc of best fit. To analyze use method of slices (Reference 30) & compute moments about center of arc. This takes into account reduction in net driving moment caused by weight of sliding mass acting in opposite direction. (Reproduce dwg. from sheet 1)

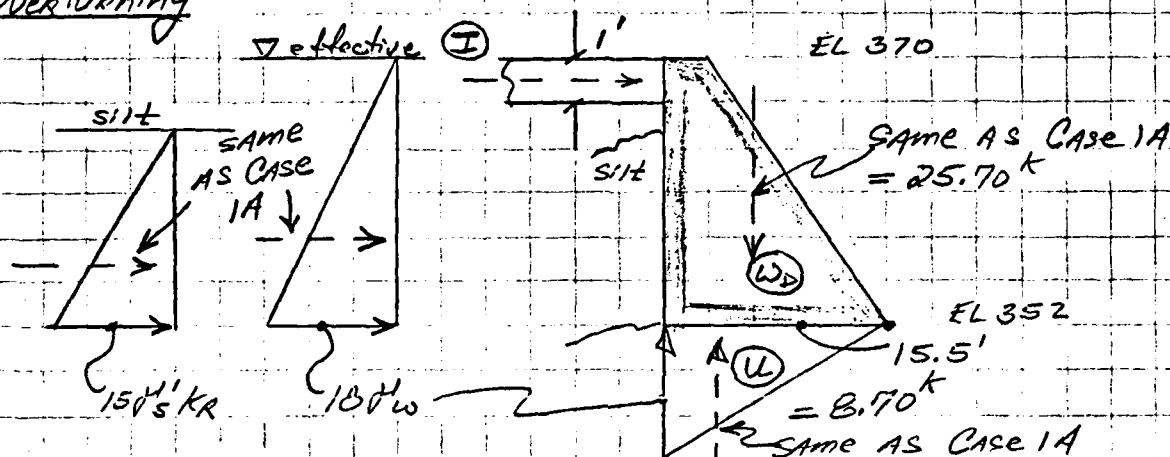
CASE 2 - Normal Pool plus Ice Load. Flashboards are normally removed for winter. MAY. recommended ice load (Ref. 1) = 10 k/ft & ice 2' thick. Use 5k/ft & ice 1.0' thick as appropriate for conditions at this dam.

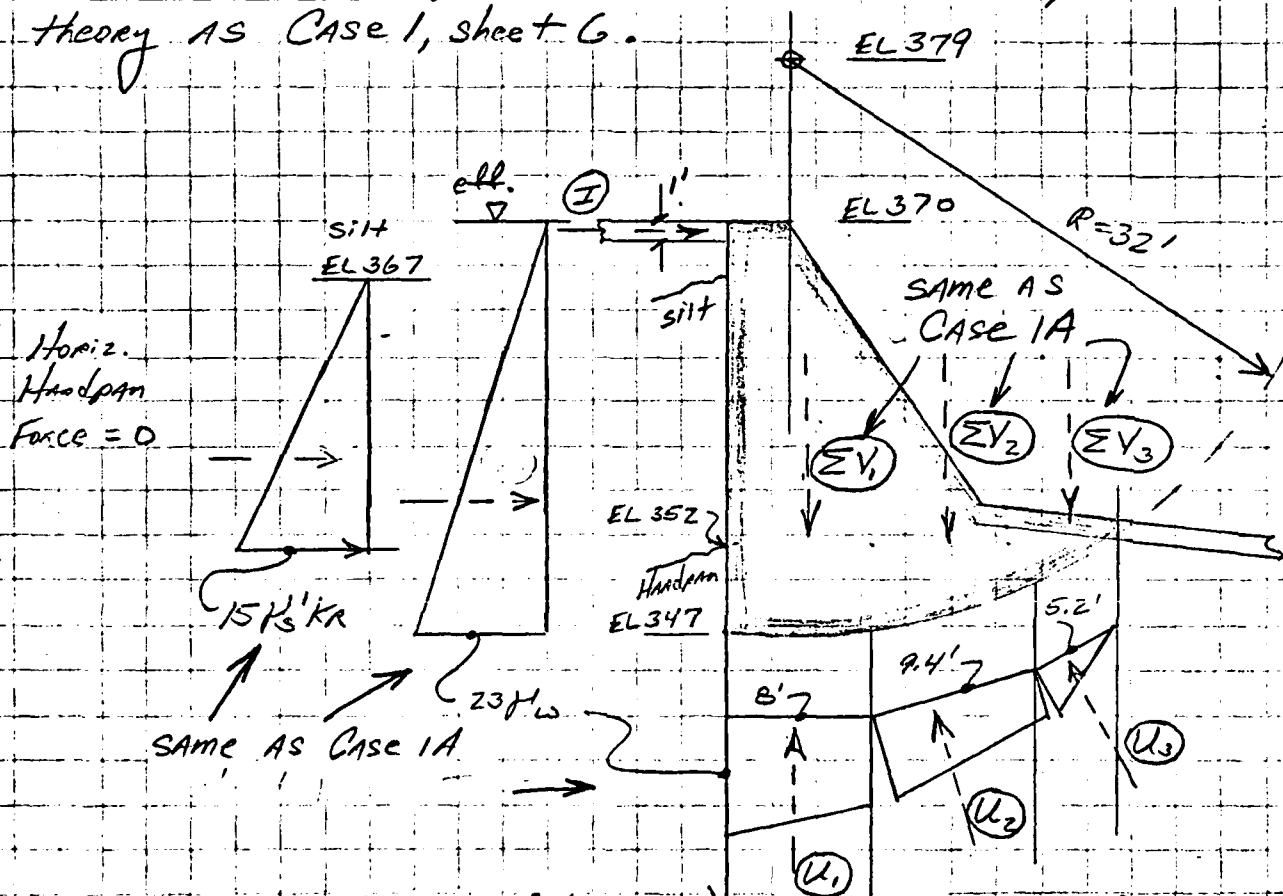
CASE 2 - SLIDING Use same critical failure plane & theory as Case 1, sheet 6.

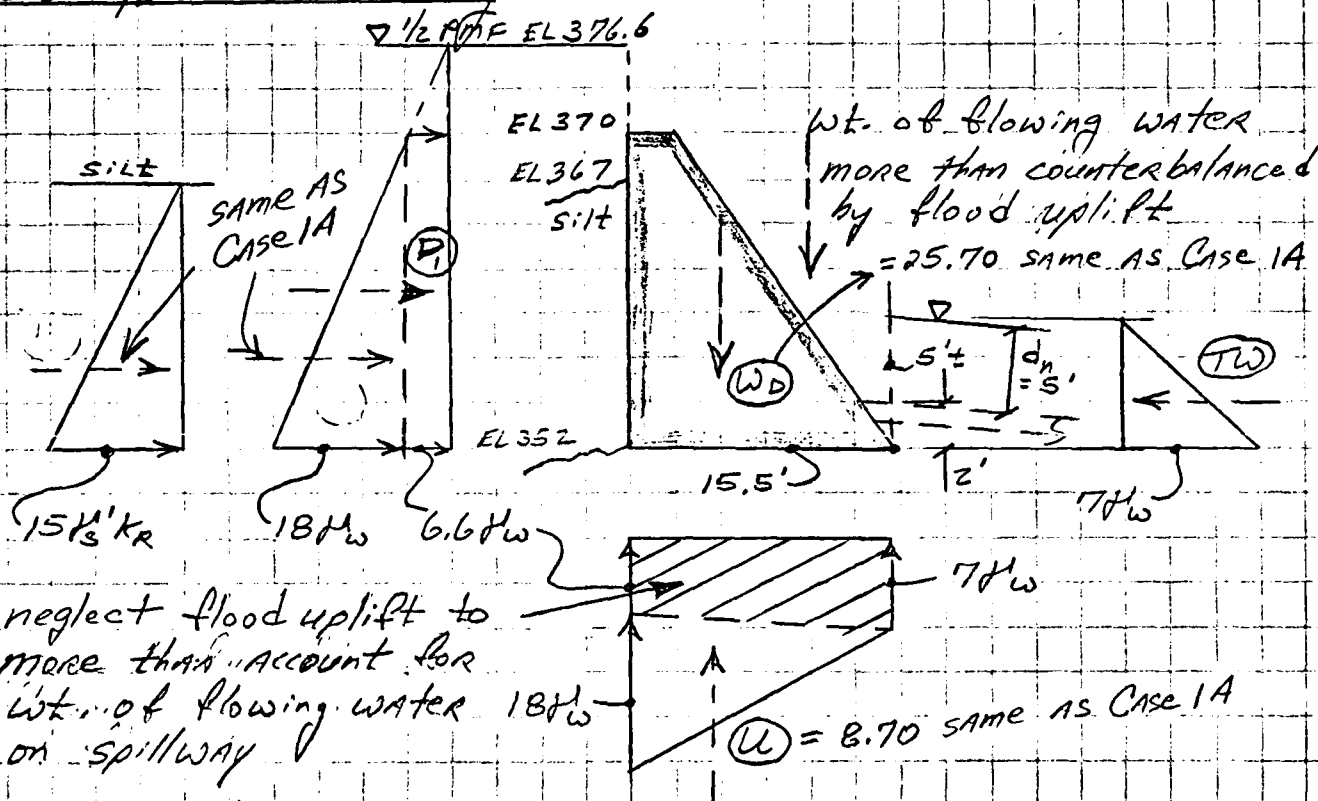
CASE 3 - $1/2$ PMF OVERTURNING

$$d = 37.64 / 17.0 = 2.21' \times \frac{b}{15.5} = \boxed{0.14b} < \frac{1}{3}b$$

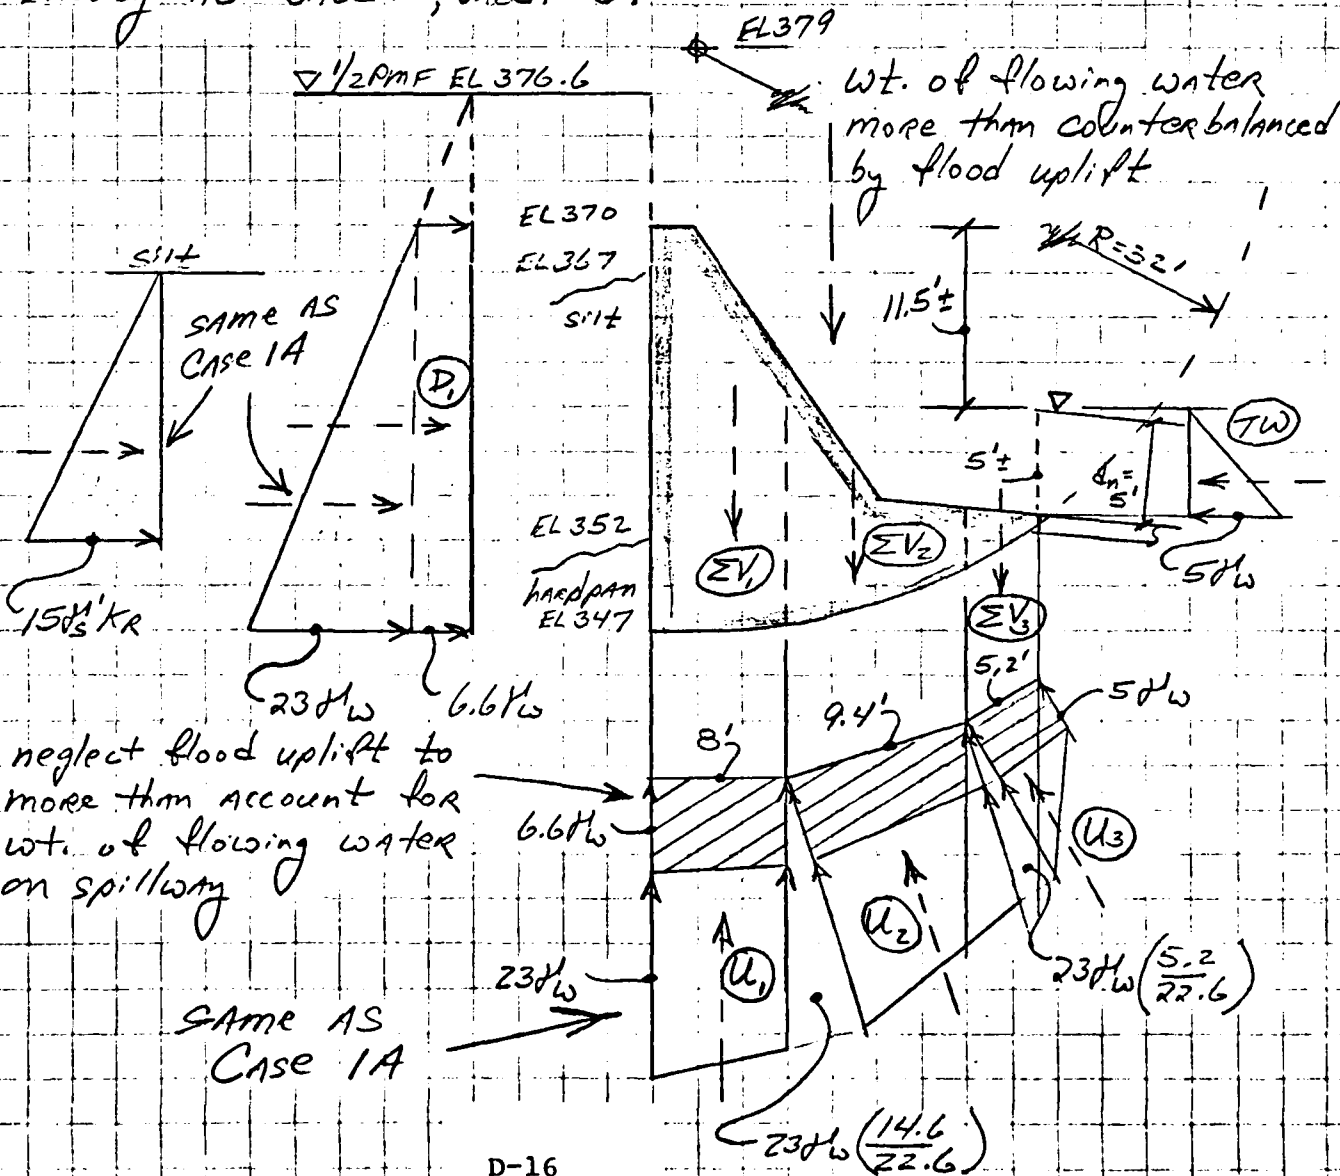
CASE 3 - SLIDING Use same critical failure plane & theory as Case 1, sheet G.

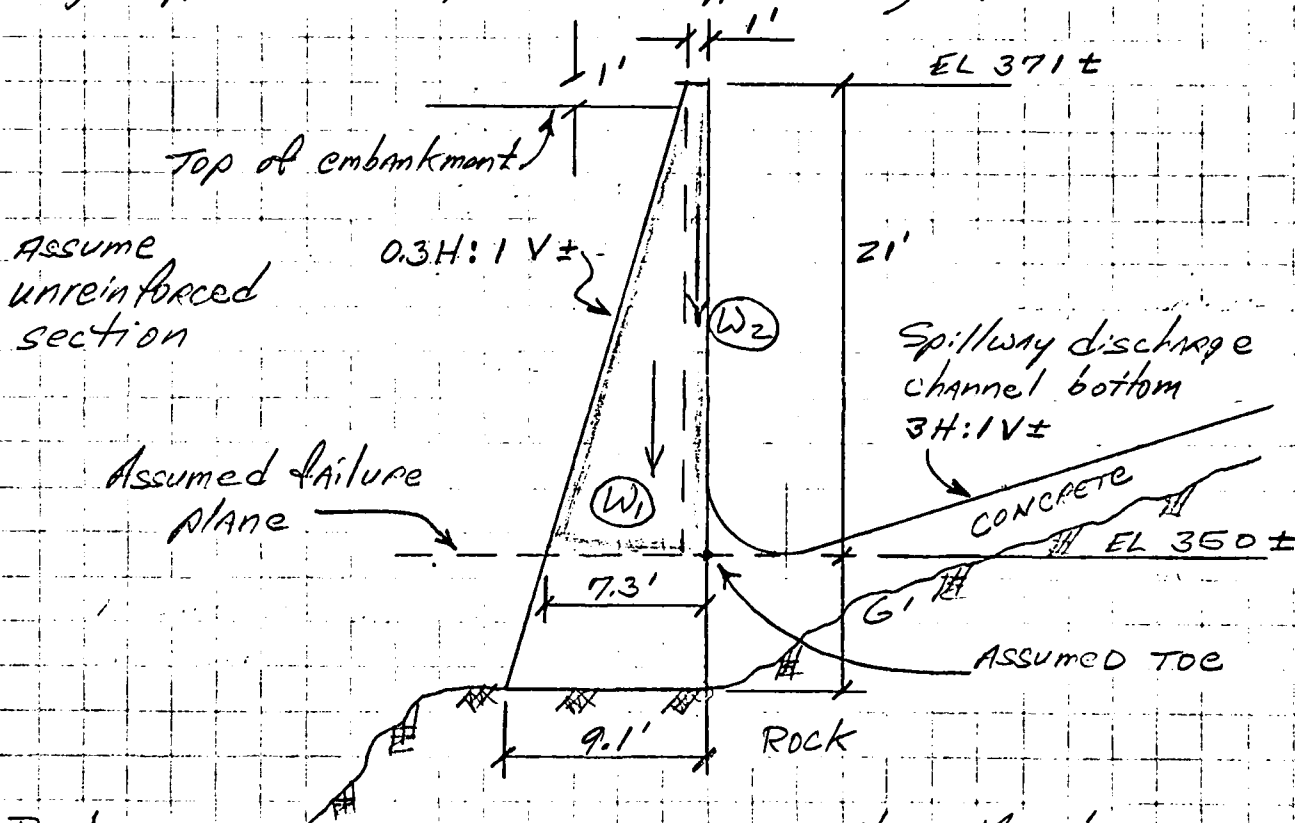
STABILITY ANALYSIS OF RIGHT TRAINING WALL OF SPILLWAY

CROSS SECTION FOR ANALYSIS (AT MAX. UNSUPPORTED height which occurs just d/s of spillway toe, see dwg. Appendix G-1 & photos Appendix A)

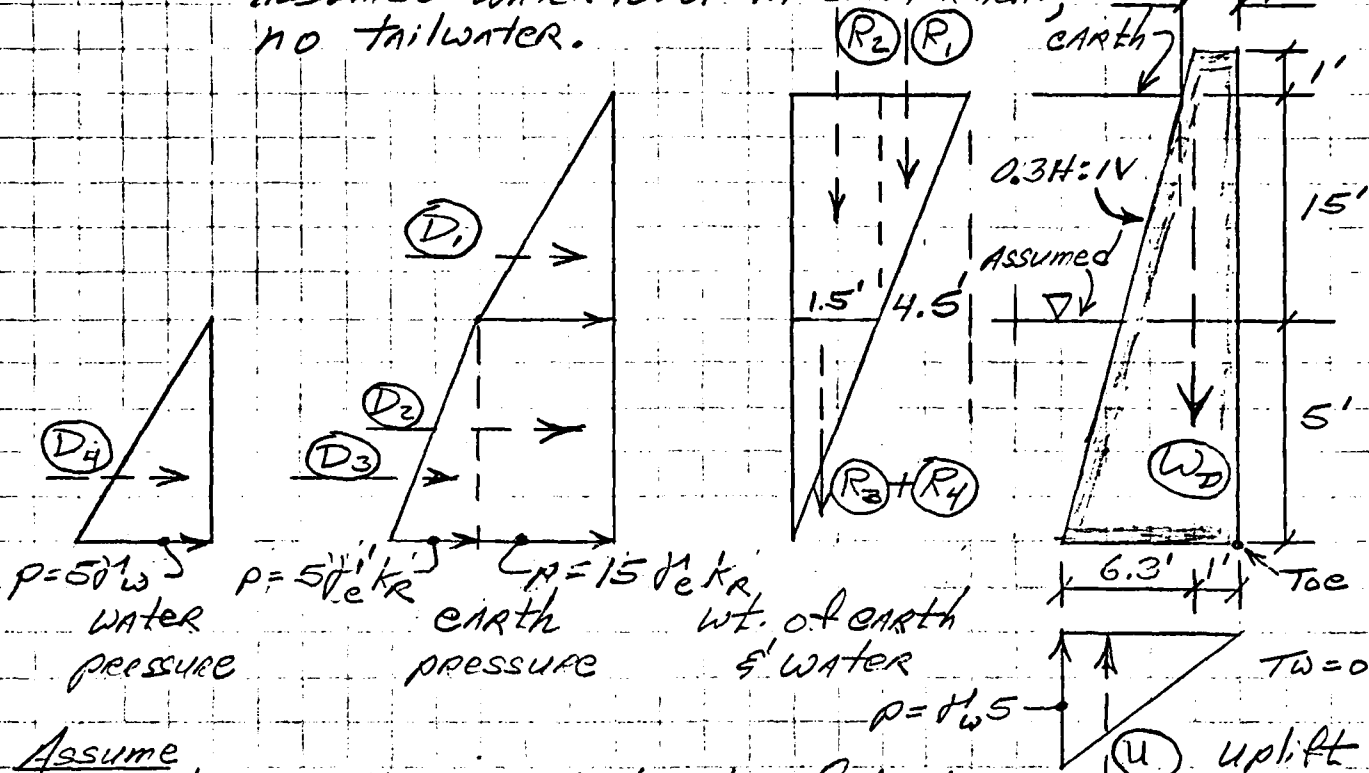
CASE 1 - Normal conditions, full uplift at heel due to assumed water level in embankment, no tailwater.

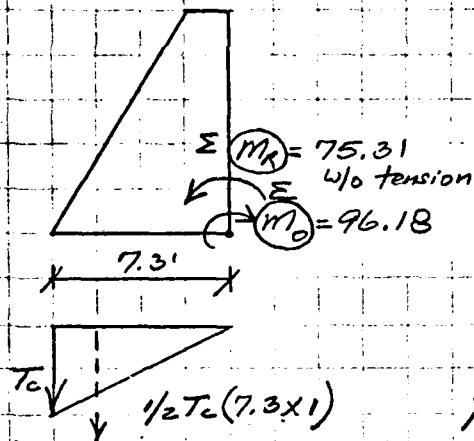
Tensile Stress In Concrete For Overturning Stability

T_c = max. tensile stress in concrete
 $T_{c, \text{allowable}} = 3 \text{ to } 6 \sqrt{f'_c}$ (ACI Code)

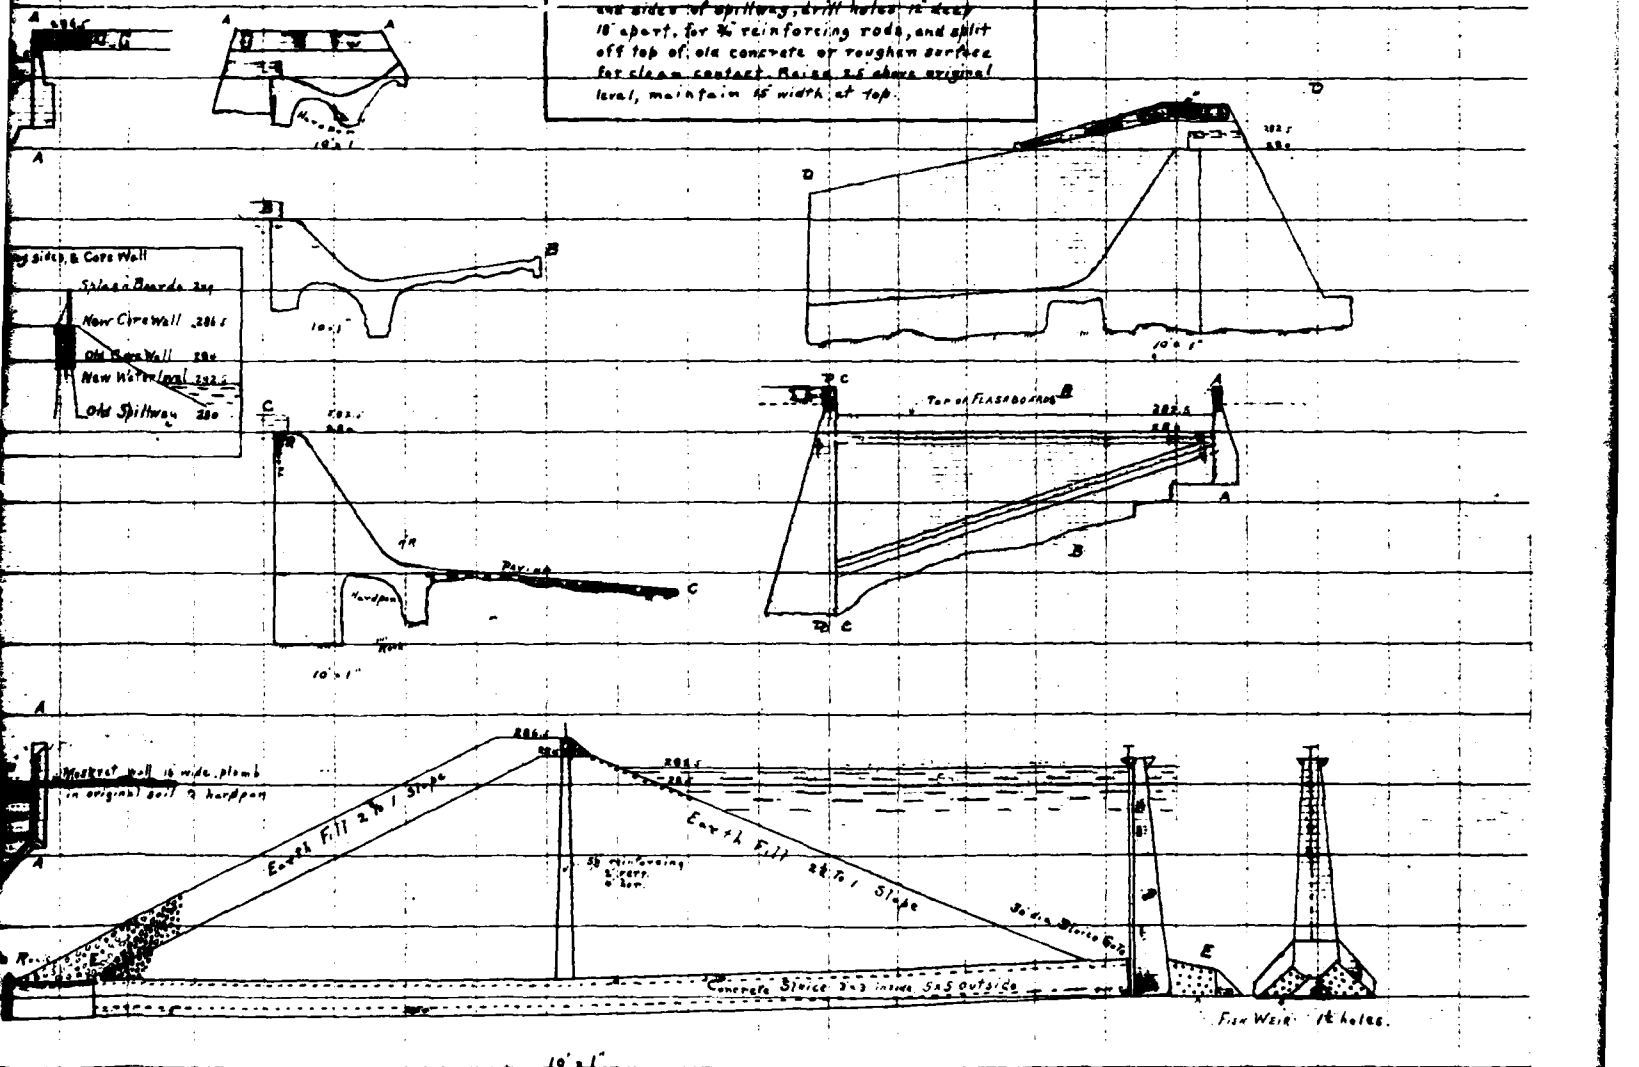
Raise Core Wall In This Area
To Match Core Wall On South
Side Of Spillway - To Elev. 266.7

Notes:- For new concrete, to raise core wall
 and sides of spillway, drill holes 12" deep
 18" apart, for $\frac{3}{4}$ " reinforcing rods, and split
 off top of old concrete or roughen surface
 for clean contact. Raise SS above original
 level, mainlain 15' width at top.
